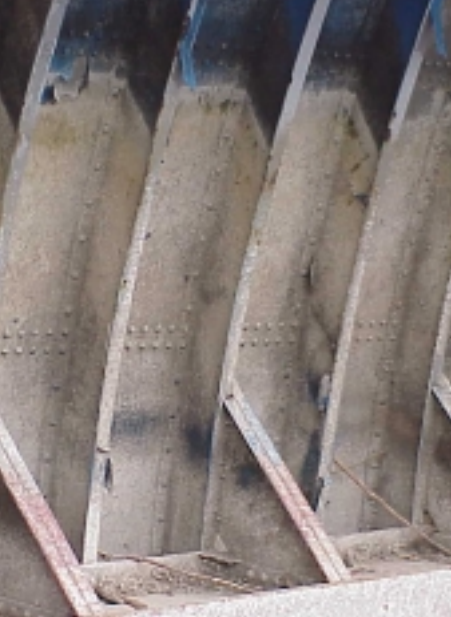
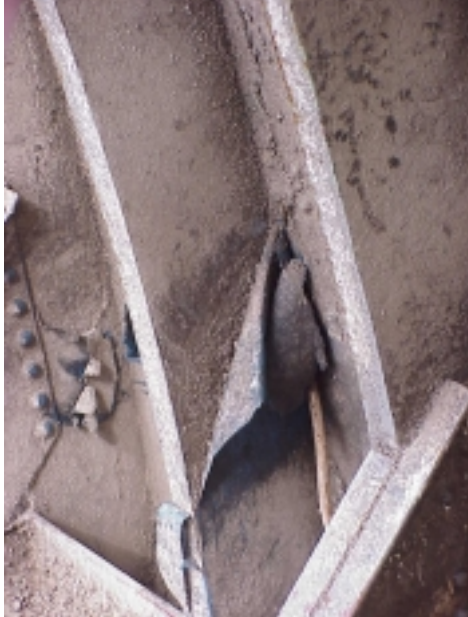
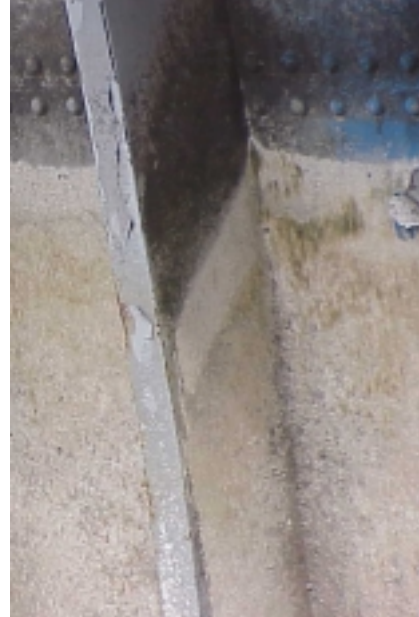
2001 - Epoxy E-303, MIL-P-24441 F150 & F151, Thane Coat after 9 years service.
Most of the Thane Coat is gone due to poor intercoat adhesion to the epoxy.

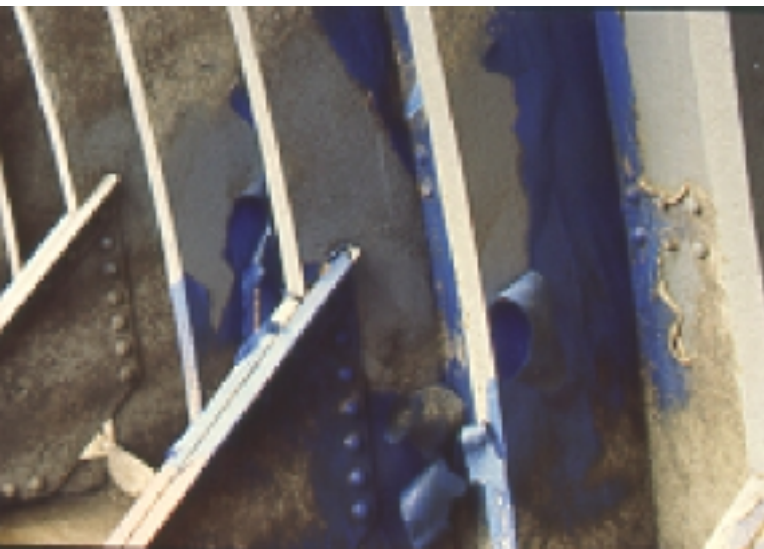
1997 - Epoxy E-303, MIL-P-24441
F150 & F151, Thane Coat after 5 years
service.

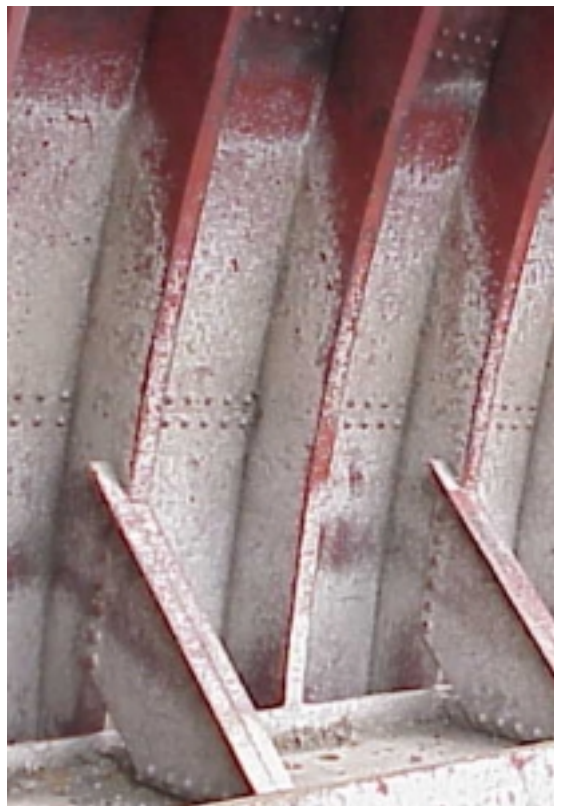
2001 - Vinyl VZ-108, V-106 after 24 years
service.

White area is river scum. There is a minor
amount of rust on the edge of each rib. All
other areas are protected.
